Manhole Inspection Summary

Manhole # S17SS_012MH

Location Address: **2320 ANOKA AVE** Cross Street: **TOWANDA AVE**

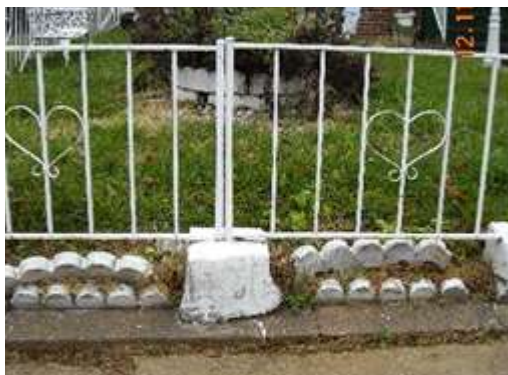
Location View

Cannot Access - Buried - Manhole Existing Confirmed by CCTV

Comments **BELIEVE IT IS LOCATED ON PRIVATE PROPERTY BURRIED BENEATH A RAISED PLANTER WHICH WAS CONSTRUCTED ABOVE IT. WOULD HAVE TO REMOVE IT BEFORE ABLE TO CONFIRM EXISTENCE OF MANHOLE.**
